In Form Inspection

Property Inspection Report

Property address: **321 Somewhere St
Pt Ludlow, WA 98365**

Inspection date: **Saturday, December 8, 2018**

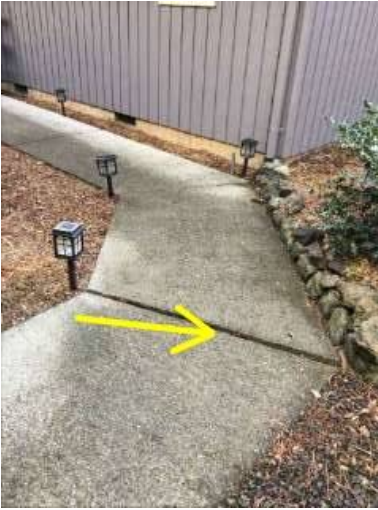
Photo 1-1

A trip hazard exists at sidewalk due to cracks and settlement. It is likely that the elevated section could be picked up and then replaced after regrading the soils beneath it. Cost effective too!

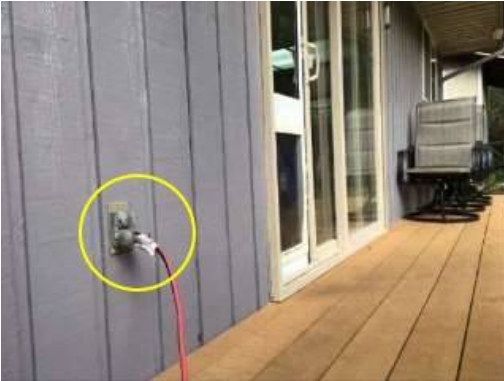
Photo 2-1

One or more outdoor electric receptacles appear to have no ground fault circuit interrupter (GFCI) protection. This is a safety hazard due to the risk of shock. A qualified electrician should evaluate to determine if GFCI protection exists, and if not, repairs should be made so that all outdoor receptacles within six feet six inches of ground level have GFCI protection. For example, install GFCI receptacles or circuit breaker(s) as needed.

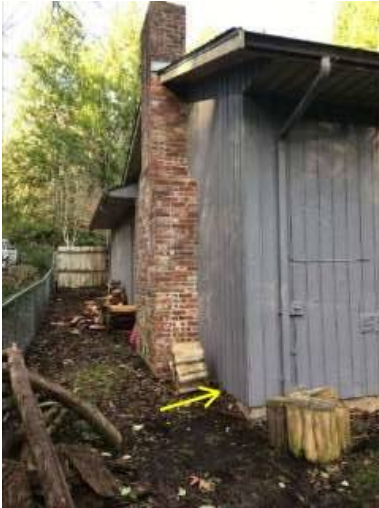
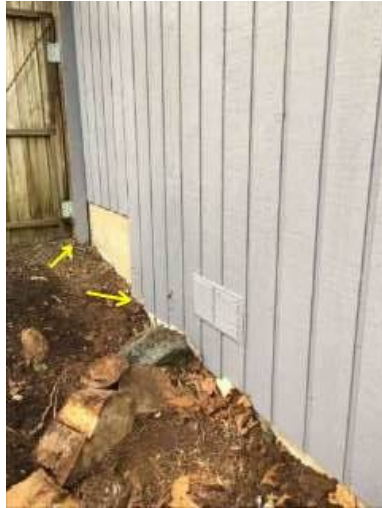
Soil is in contact with or less than six inches from siding and/or trim. This is a conducive condition for wood destroying insects and organisms. Also, the soil should be graded and/or removed as necessary so there are at least six inches of space between the siding and trim and the soil below.

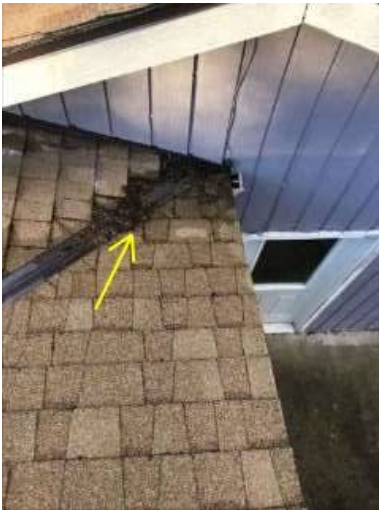
4) This exterior door, to the garage, did not open and close freely due to the frame and door rubbing against each other. The condition may be attributed to past overflows at the downspout adjacent to the top of the door. The door jamb will likely need to be re-squared in order to alleviate this condition.

Photo 4-1 Exterior door to garage and flashed valley, clogged with tree debris, above downspout.

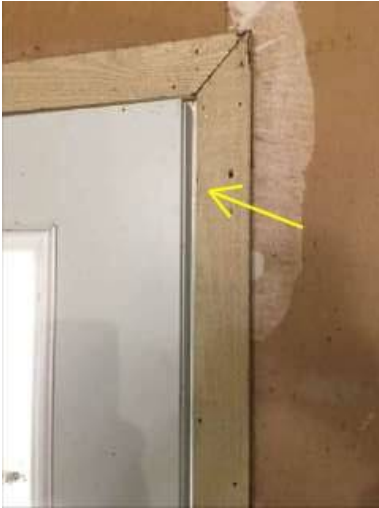
Photo 4-3 Door binds at top of jamb and does not close easily.

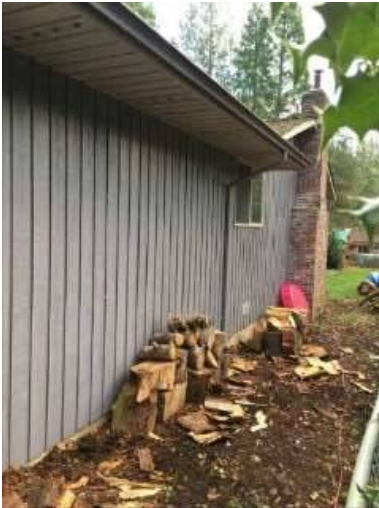
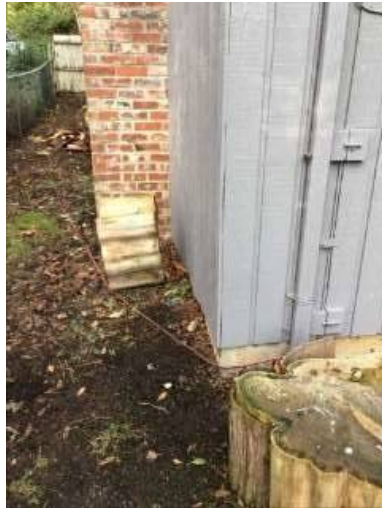
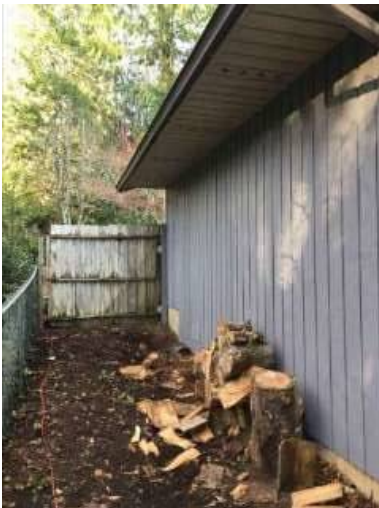
5) Items, such as firewood, and anything really, should not be stored in contact with siding as this is a conducive condition for pests such as insects and rodents.

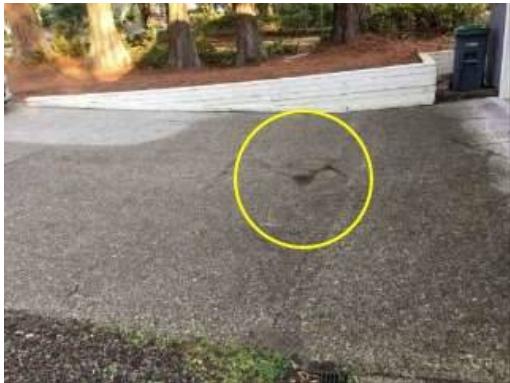
Photo 6-1

6) Cracks in the driveway will continue to deteriorate further if not addressed, by removing broken areas and replacing with new concrete for example.

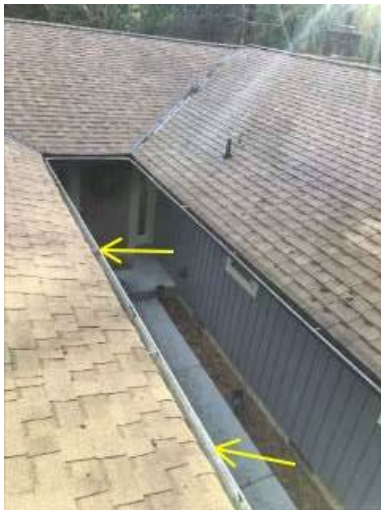
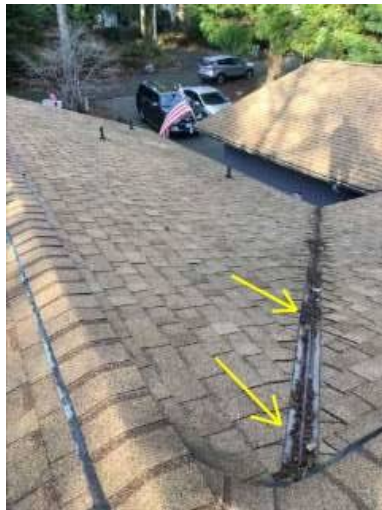
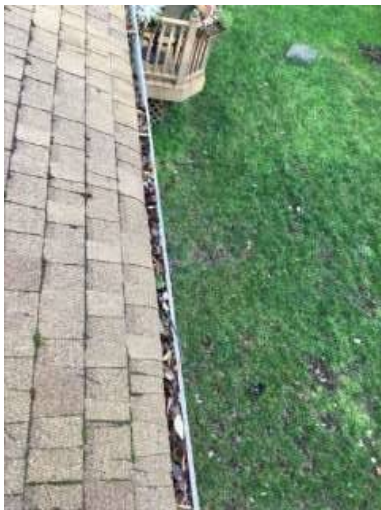
Debris has accumulated in one or more gutters. This is a conducive condition for wood destroying insects since gutters may overflow and cause water to come in contact with the structure's exterior or make water accumulate around the foundation. Gutters should be cleaned now and as necessary in the future.

Tree debris has also collected in several of the roofs valleys in the flashing, which impedes their intended function and can result in rainwater backing up under roof covering.

It is important to keep tree debris from "damming" gutters and flashing!

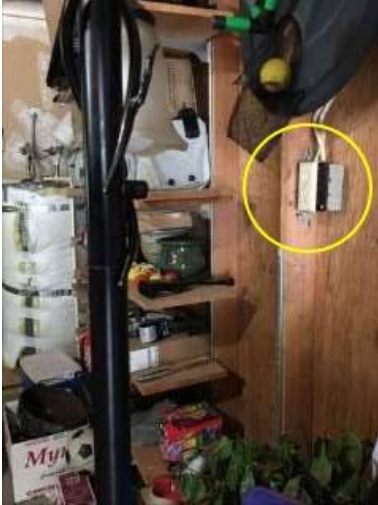
Photo 8-1

One or more garage electric receptacles appear to have no ground fault circuit interrupter (GFCI) protection. This is a safety hazard due to the risk of shock. A qualified electrician should evaluate to determine if GFCI protection exists, and if not, repairs should be made so that all garage receptacles, except for one for use with a refrigerator or freezer, have GFCI protection. For example, install GFCI receptacles or circuit breaker(s) as needed. Newer building code also requires AFCI protection for bedrooms and other living spaces. more info at: afcsafety.org

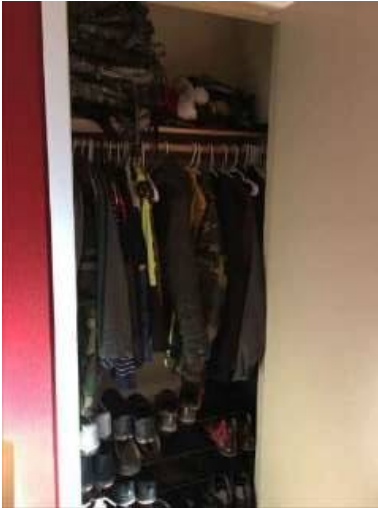
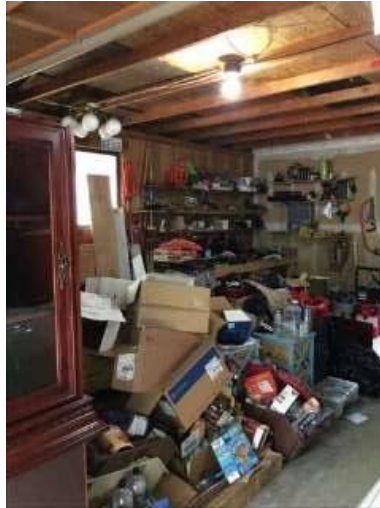
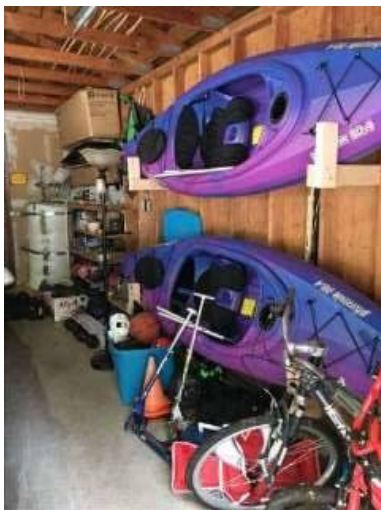
9) Stored items in the garage and throughout the house, prevented a complete evaluation of the home interior. Additionally, the circumstance exists where the inspector will have an opportunity to return for a thorough inspection of the home interior spaces after stored items are removed.

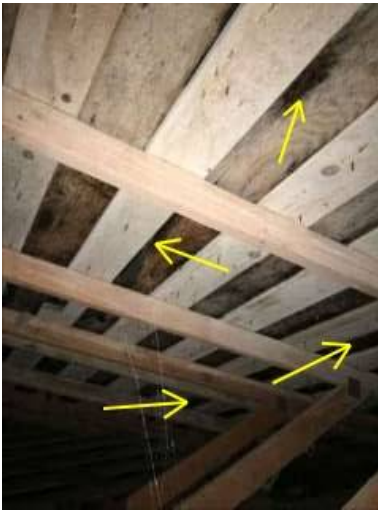
10) ⚠ Condensed water vapor is/has collected on the underside of the roof sheathing in the attic. This condition may be attributable to several factors. Additionally, this condition may have persisted for an undeterminable period in the past. Further evaluation of the condition will be required in order to determine how it may be remedied and to what extent, if any, the moisture has caused damage.

Photo 10-1 Arrows indicate locations of observed condensed moisture. Also apparent is a patina of white fungal growth. This condition was observed in a wide ranging area above the attic access hatch.

To remedy the condition of excessive moisture laden airflow into the attic from the living spaces all unsealed gaps would need to be sealed with products like, caulk, spray foam and foam tape. Also, install exhaust fans in the two bathrooms and in the laundry.

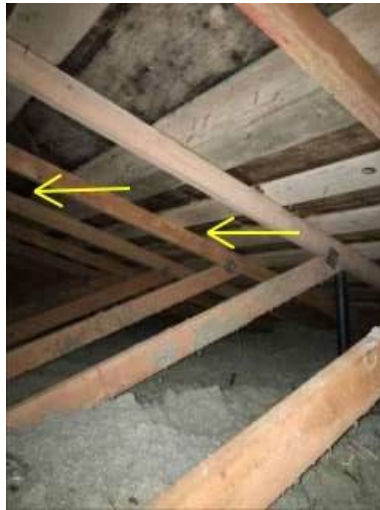
Photo 10-2 White growth, such as that observed here, during the inspection, can be mitigated by removing the source of excessive moisture. Once the moisture is eliminated the microorganism can no longer grow.

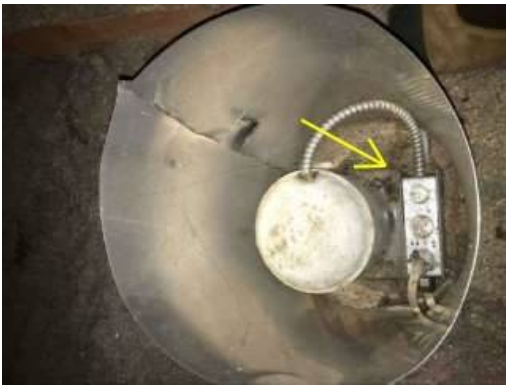
Anywhere there are unsealed gaps at the ceiling, such as junction boxes (which house wiring for lights) and other lighting, can also provide the exit path for surprising amounts of water vapor laden air into the attic. The same is true of gaps at the attic access.

Photo 10-3 Baffle, which holds back insulation from the heat of the light fixture, and gaps around fixture may be providing a path to the attic for warm moist air (there were five of these observed in the attic space).

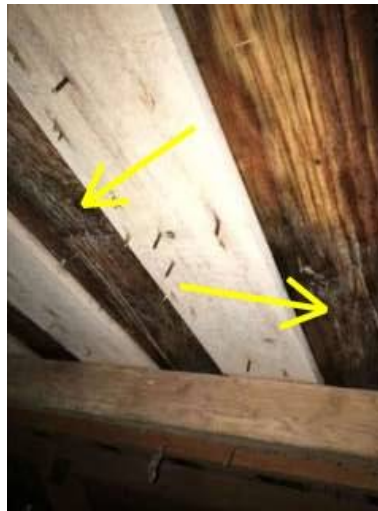
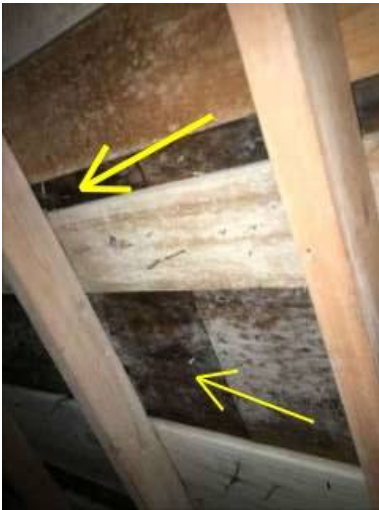
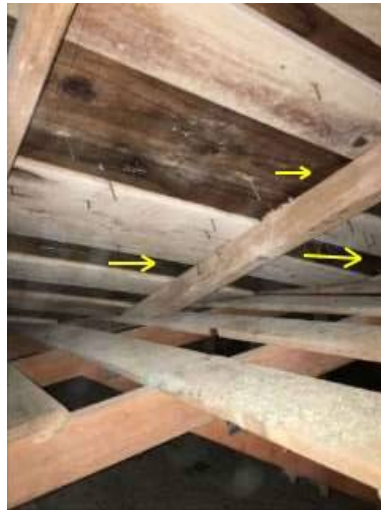
This residence does not have exhaust fans installed in the bathrooms or the laundry. This likely contributes to elevated moisture levels in the living spaces which in turn allows for more water vapor laden air to find its way to the attic.

Another factor, which may be contributing to the elevated levels of moisture in the attic, could be compromised functionality of the attic ventilation system (the two principle components of this system are (1) the holes in the "birdblock", some of which may be blocked by the loose fill insulation in the attic space and (2) the ridge vent). The ridge vent at the top of the attic provides a path for air to escape and this, combined with the holes in the "birdblock", creates the airflow that a healthy attic space needs in order to remain relatively moisture free. The functionality of the attic ventilation system will need to be restored in order to mitigate further elevated moisture levels that, in turn, provide a conducive condition for dry rot.

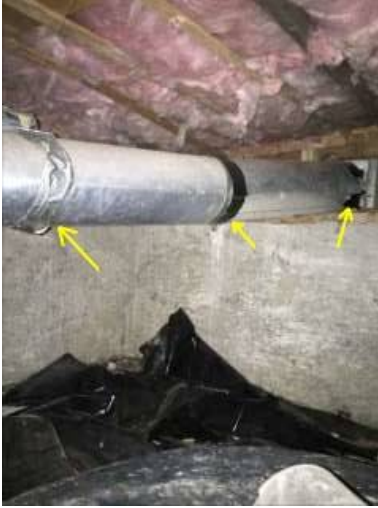
Photo 13-1

Plastic tape at dryer vent in crawlspace. This tape is not intended to be used to connect ducting sections and it should be replaced with metal duct tape.

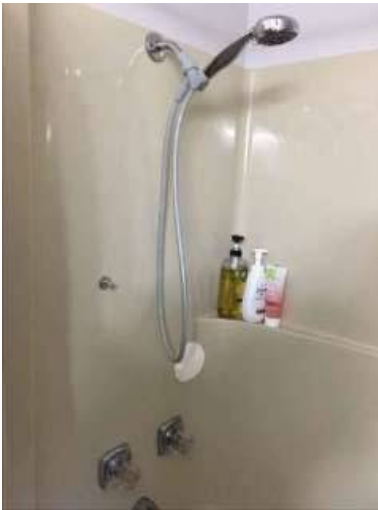
- 15) Plumbing observed to be leaking from p-trap at NW end of crawlspace. Puddle formed beneath p-trap indicated that leak, while small (a drip every thirty seconds or so), was persistent. P-trap and puddle were in/beneath this run of plumbing. Suggest that repair be made by a plumber.

Photo 15-1 Leak in p-trap beneath this fixture.

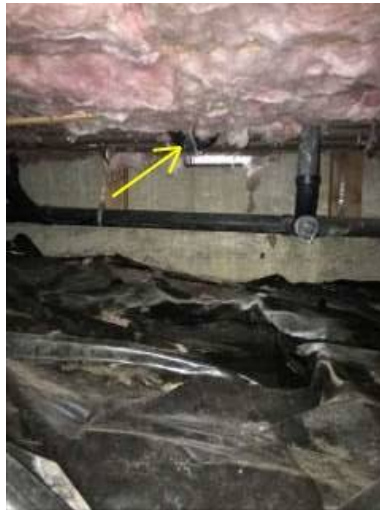
Photo 15-2 Leaking p-trap.

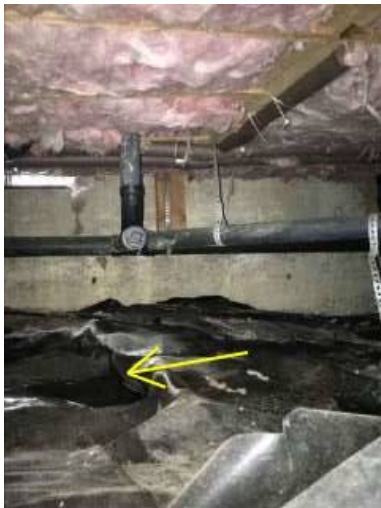
Photo 15-3 Puddle left by leak.

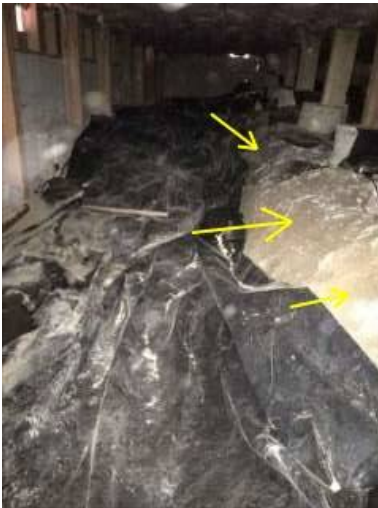
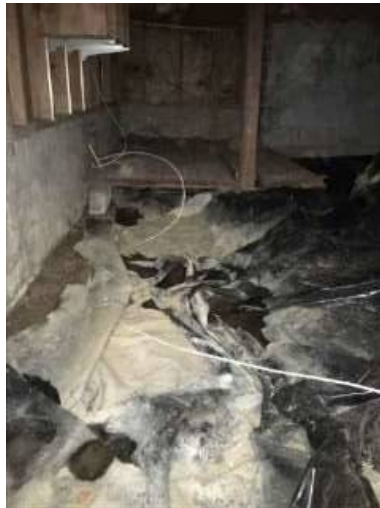
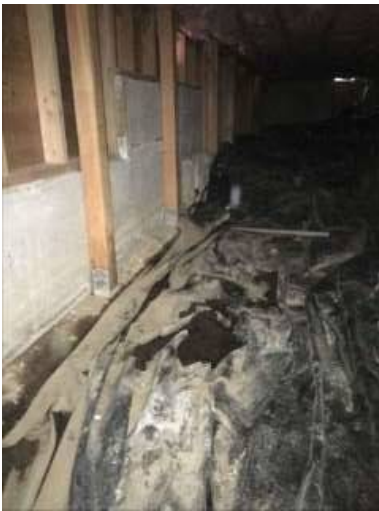
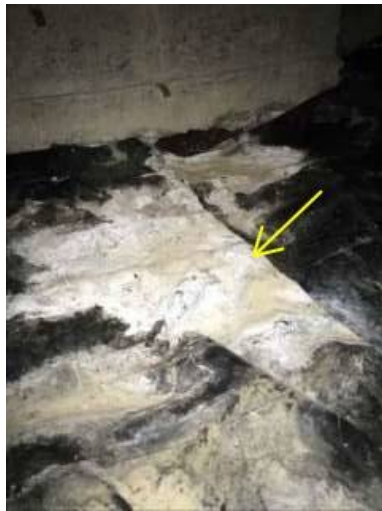
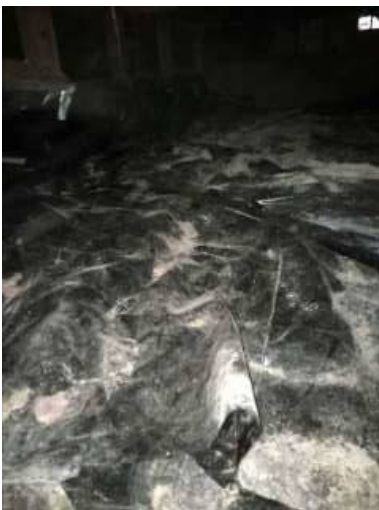
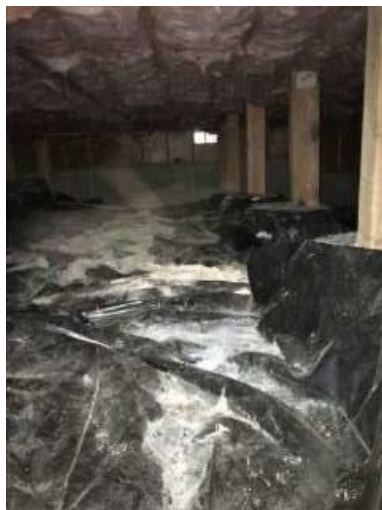
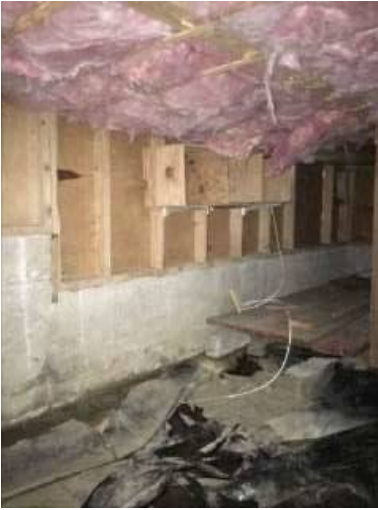
Small amounts of water were present in the crawlspace at the time of inspection (see photos). Sediments on top of the vapor barrier, left behind by water, were observed at other locations in the crawlspace. At the time of inspection, the crawl had not been subjected to prolonged rain periods as it can be throughout the year(s). It would be necessary to observe the crawlspace during the course of a prolonged rain period to determine if flooding of the crawlspace is an issue. Suggest that the crawl be observed to see if further remedy is required and to speculate on what the remedy to the flooding might be. Asking the homeowners if they are aware of past flooding episodes is also a good idea.

Vapor barrier displaced in some locations. Also, sediment staining on top of vapor barrier from previous exposure to water can be observed in the photos below.

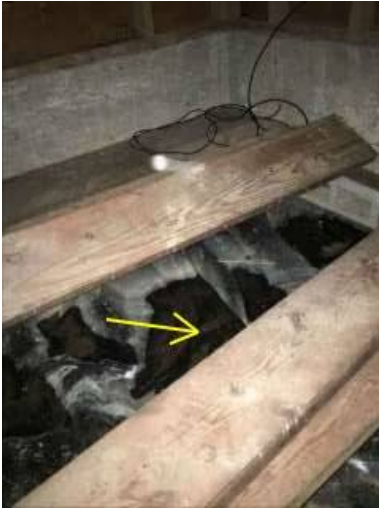
Standing water was found in one or more sections of the crawl space. Accumulated water is a conducive condition for wood destroying insects and organisms and should not be present in the crawl space. A qualified contractor who specializes in drainage issues may need to be employed in the future. Typical repairs for preventing water from accumulating in crawl spaces include:

Photo 18-3 Standing water and sediment deposits.

- Repairing, installing or improving rain run-off systems (gutters, downspouts and extensions or drain lines)
- Improving perimeter grading
- Repairing, installing or improving underground footing and/or curtain drains

Ideally, water should not enter crawl spaces, but if water must be controlled after it enters the crawl space, then typical repairs include installing trenches, drains and/or sump pump(s) in the crawl space.

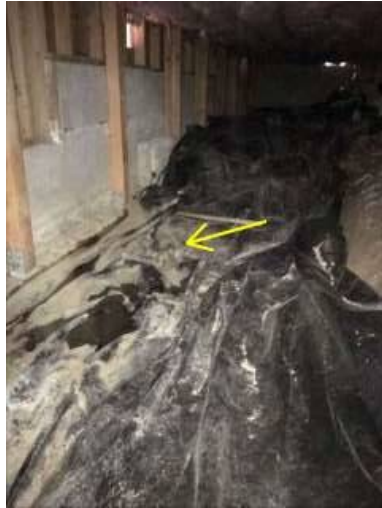
Photo 18-4 The light/white coloring on top is sediment staining.

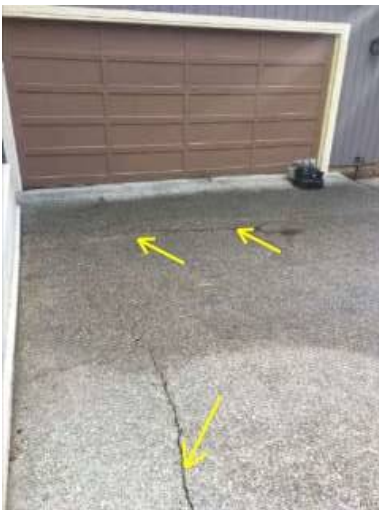
Photo X-15 Driveway cracking.
